Federal Aviation
Administration

Early Implementation Experiences

Presented to: Aircraft Electronics Association

Date: February 2011

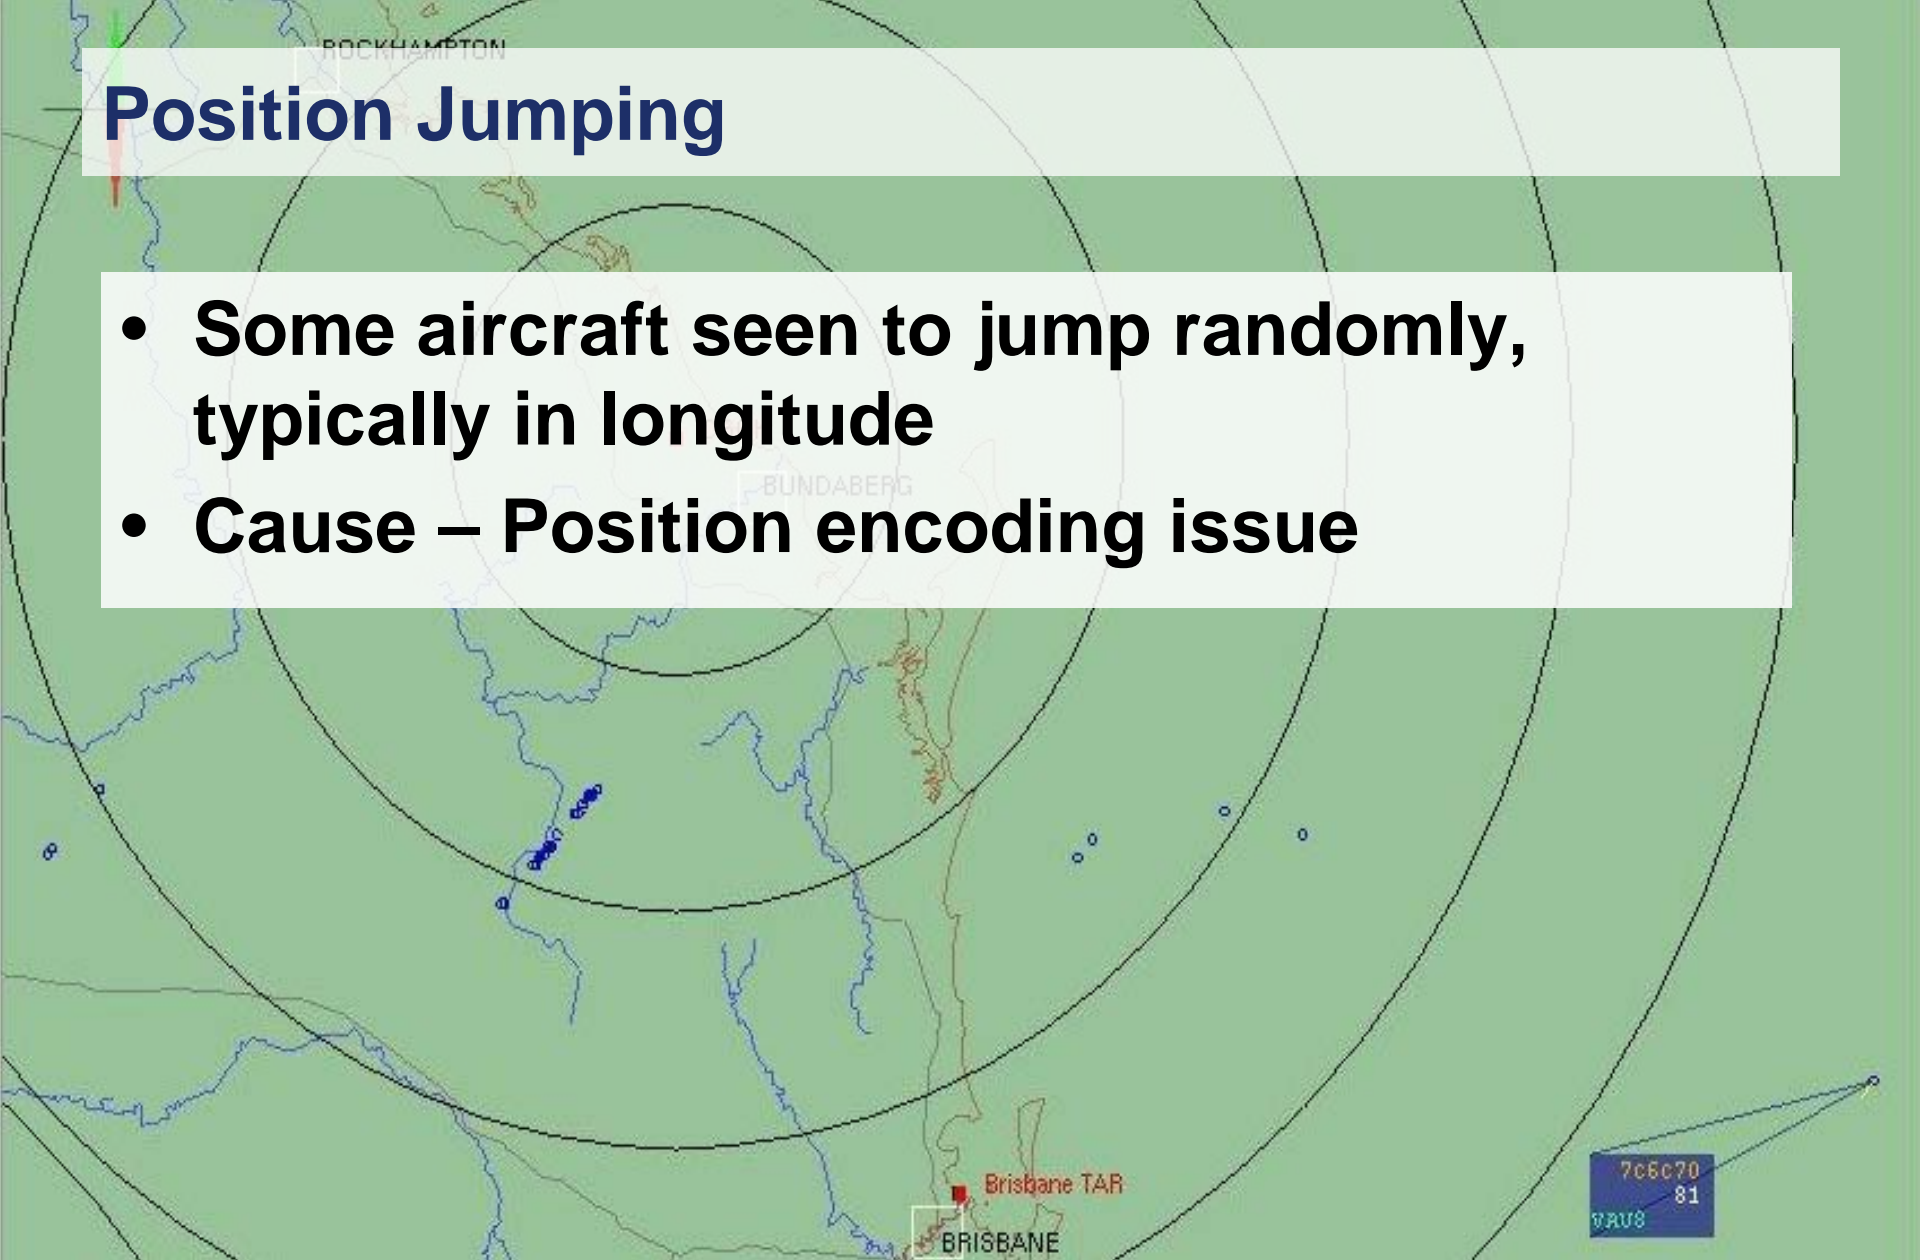
Position Jumping

- **Some aircraft seen to jump randomly, typically in longitude**
- **Cause – Position encoding issue**

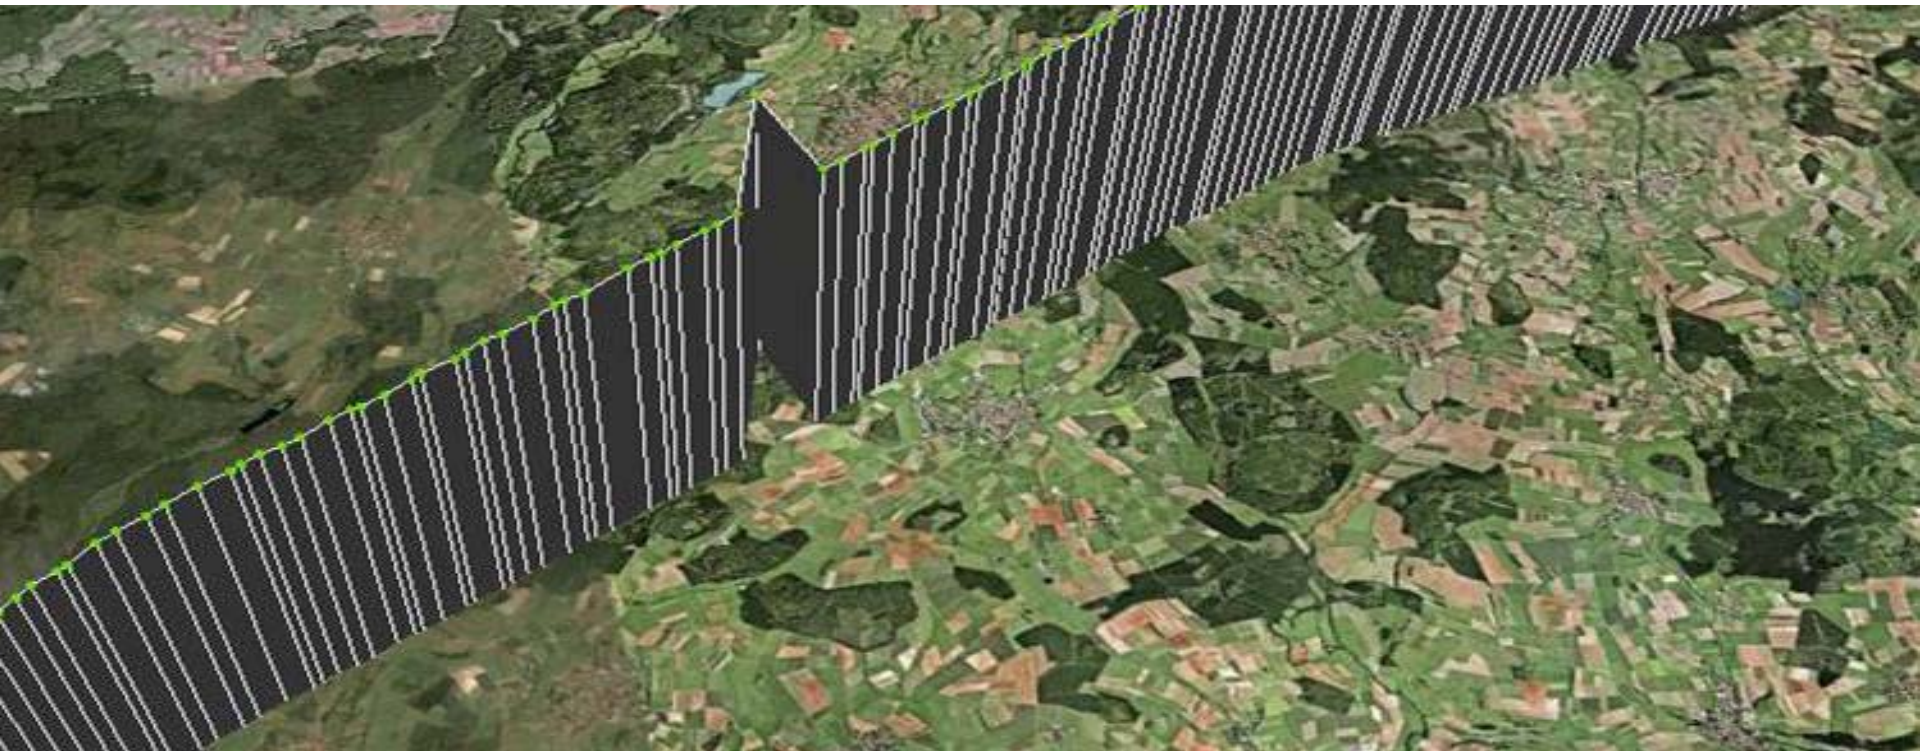
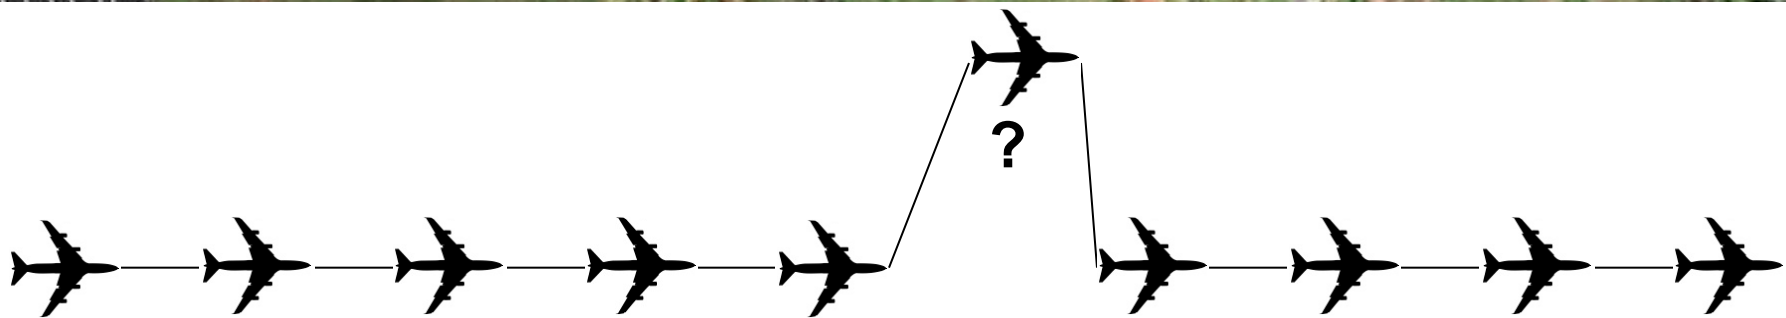
Position Jumping

- **Known transponder related issue solved by Service Bulletin**
- **Noisy track indicating good position quality**

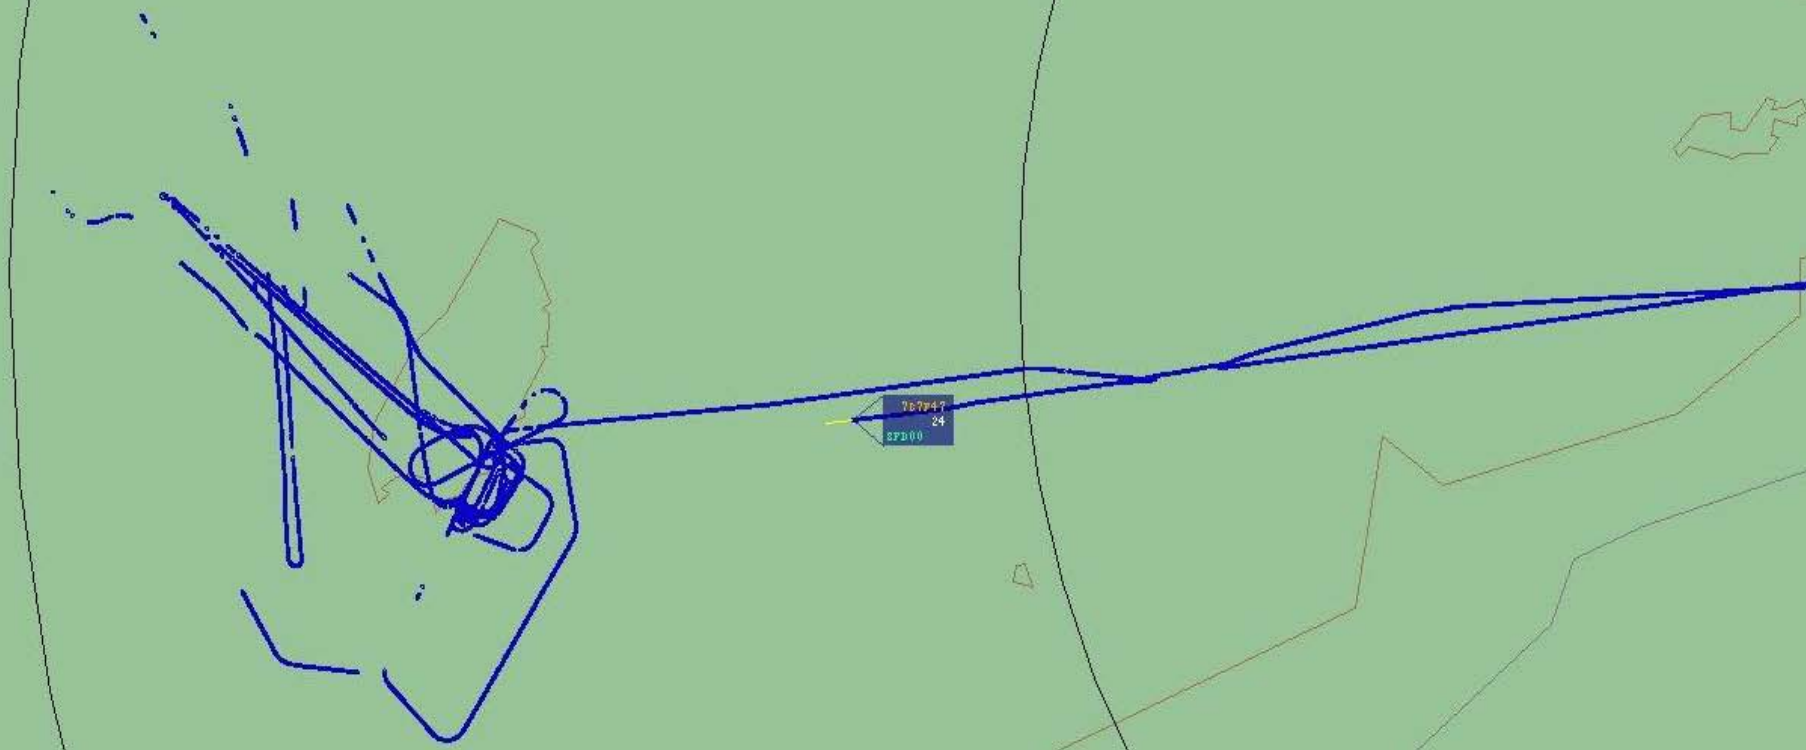
Integrity Errors

- **Error – Transponder broadcasts an Integrity value one category too low**
- **Cause – Integrity encoded based on accuracy rather than integrity**

- **NUC normally zero but occasionally jumps to 3**
- **Possibly FMS data source**

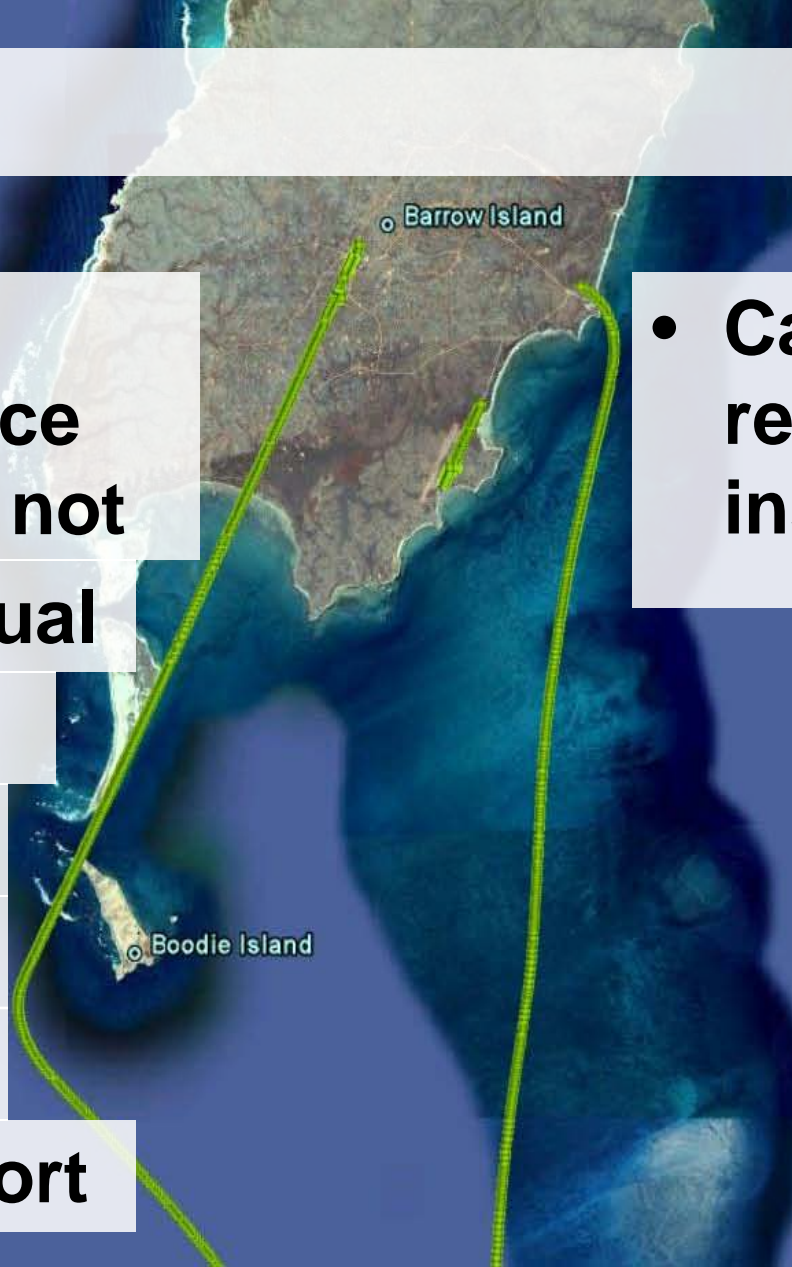
Track Bias

- **Error – Surveillance data does not match actual flight path**
- **Aircraft takes off, lands at same airport**

- **Cause – inertial reference system installation**
