RVSM Heightens Need for Precision in Altitude Measurement

Part 2 of a 2-part series

BY FLIGHT SAFETY FOUNDATION STAFF

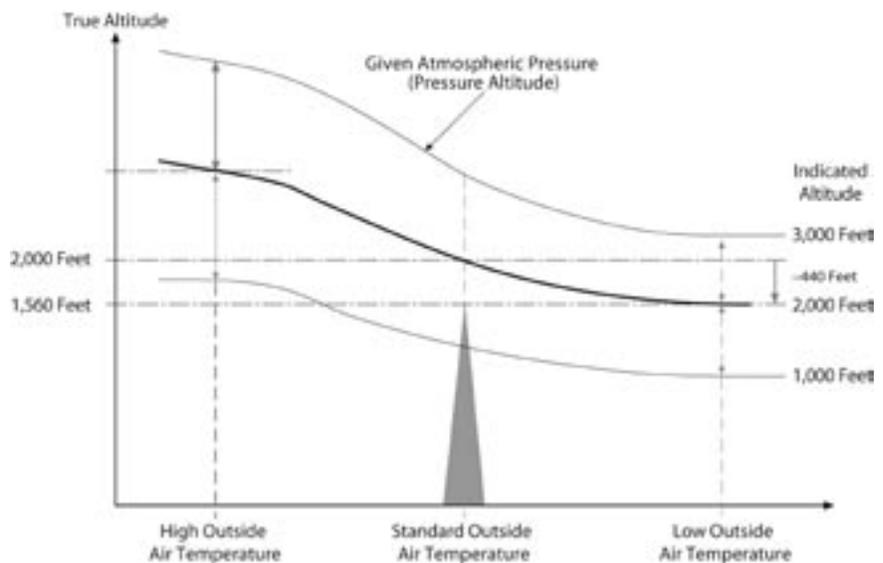
Figure 6
Effects of Temperature on True Altitude

Just as pilots adjust the altimeter settings for nonstandard air pressure, a correction also is required—in some situations—for nonstandard air temperature. When the air temperature is warmer than the standard temperature for a specific height in the atmosphere, the true altitude is higher than the altitude indicated on the altimeter. When the air temperature is colder than the standard temperature, the true altitude is lower than the indicated altitude. Moreover, in extremely cold temperatures, the true altitude may be several hundred feet lower. (See Figure 6)
